REMEDIAL FORENSICS TO IRON FOUNDRIES

ABSTRACT

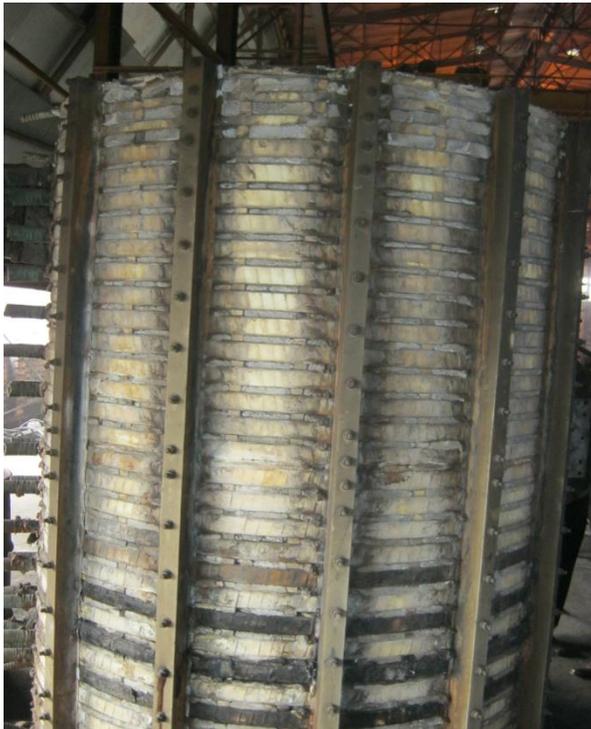
We found the furnace was kept in dismantled condition (Fig.2) inside the foundry. It had a height of about 217 cm and internal diameter of about 172 cm. The thickness of the refractory lining of the crucible along the inner side of the furnace was about 23 cm.

Figure2. The furnace kept outside in dismantled condition.

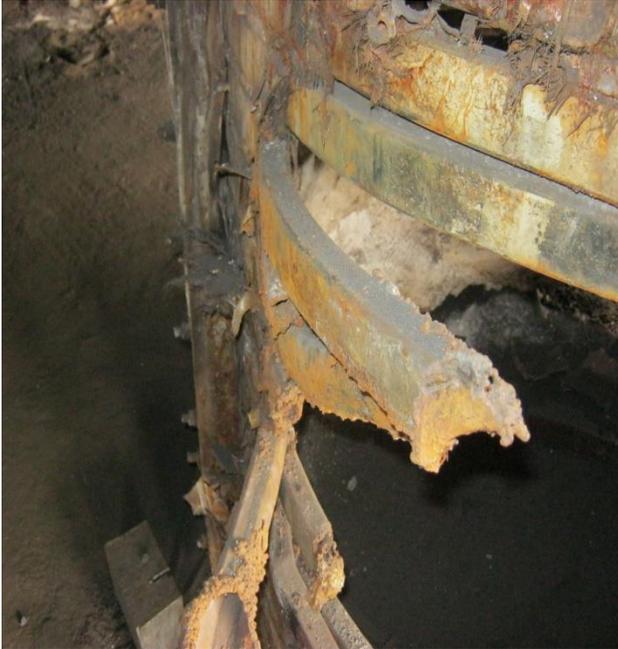
It was found that from about 57 cm up to 107 cm of height from the ground level, the hollow copper pipes melted and sheared off, bent outward (Fig.3 and Fig.4) with molten iron flux sticking to it (Fig.5) at about 3'O clock position with respect to inlet/ outlet of water jet (Fig.6). The inner crucible part inside the furnace at this position suffered major damage. More over it was observed from the remnants of the molten flux that the crucible was one third filled at the time of blast.

Figure3. Hollow Copper pipes bent outward.

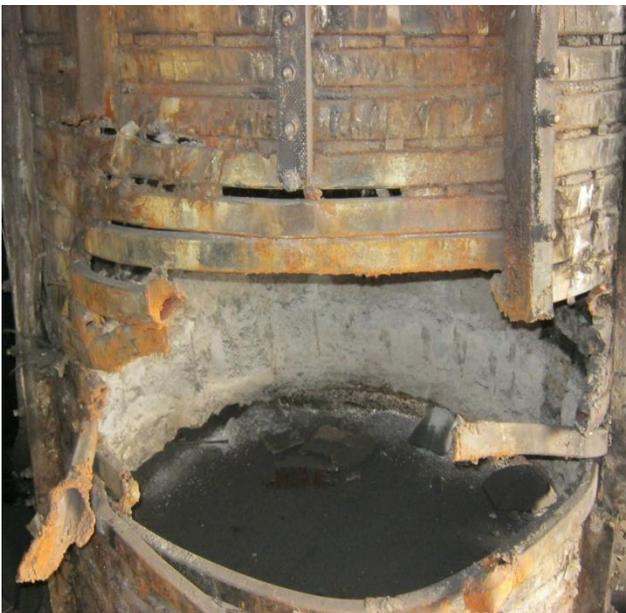
Figure4. Hollow Copper pipes sheared off and bent outward at the position of blast.

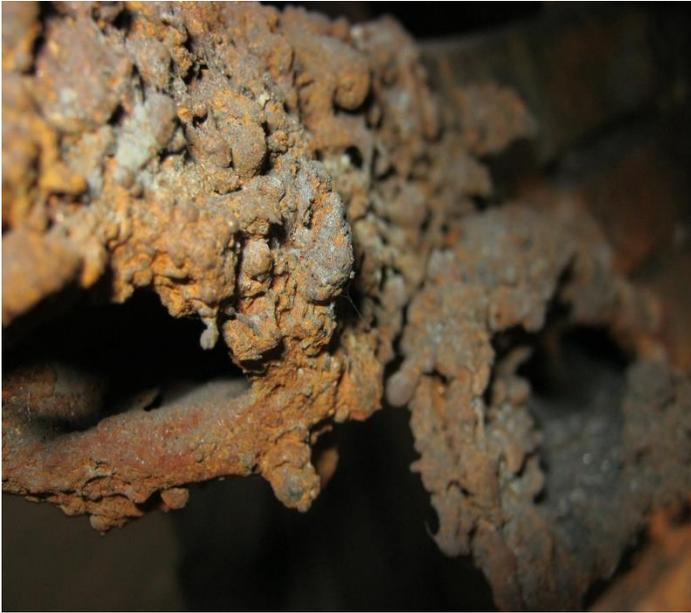
Figure5. Molten iron (after solidification) sticking around hollow copper pipes.

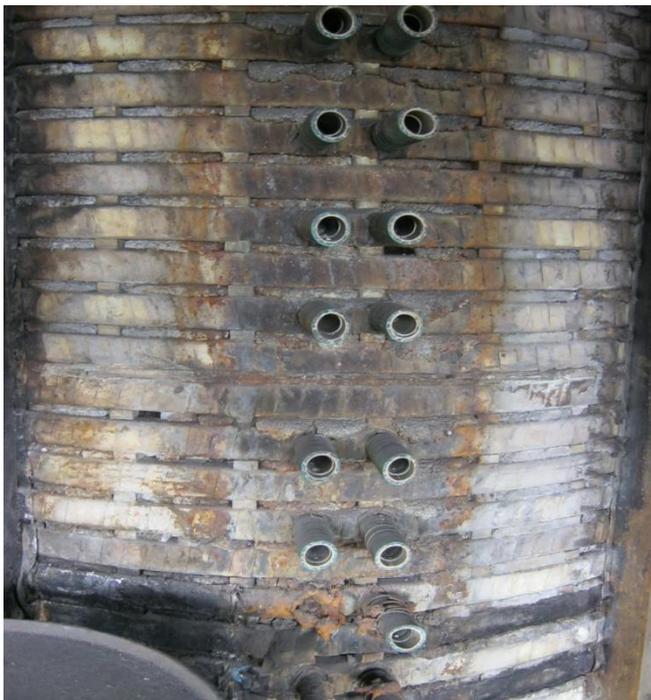
Figure6. Inlet and outlet of water through hollow copper pipes.

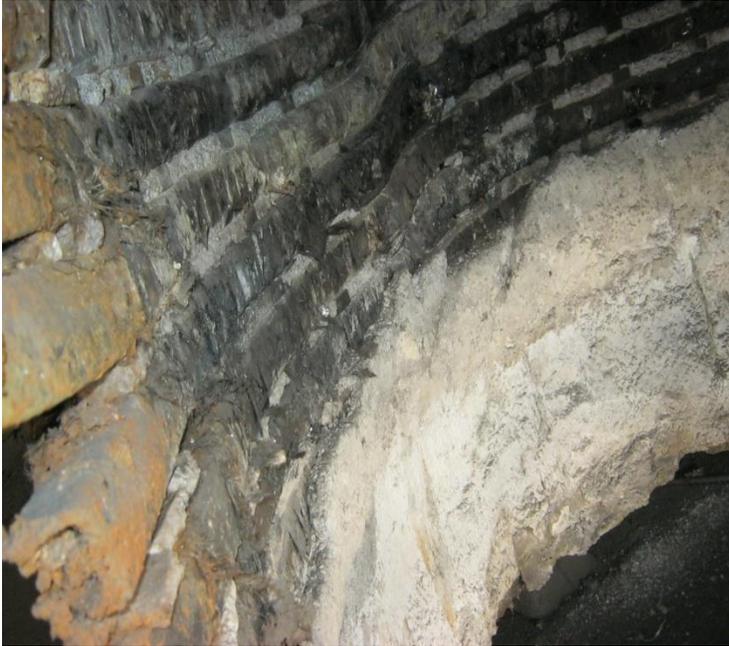
The aforesaid observation suggested that the lining of refractory material of the inner side of the furnace making the crucible part happened to have bore damages (development of cracks/ fissures) (Fig.7) at the affected position and therefore copper pipes came in contact with the molten flux at the furnace temperature which is much higher than the melting point of copper. As a result the copper pipes melted and water circulating through the hollow copper pipes came in physical contact with molten iron. The molten iron flux being at a much higher temperature than the steam point of water (100°C at 76 cm of Hg) the circulating water immediately vaporized and underwent expansion that caused the blast.

Figure7. The damaged refractory lining on the crucible part.

The remedies to such type of incidents are manifolds. It starts from the makers of induction furnaces. The thickness of the refractory lining of the crucible should be optimum. The choice of refractory material should be governed by the nature/ type of melt. The nature of the refractory material should strictly be acidic or alkaline or neutral in accordance as the slag material and the atmosphere of the charge is acidic or alkaline or neutral respectively. Depending on the operating environment, they need to be resistant to thermal shock [7], chemically inert and or have specific thermal conductivity and their coefficients of thermal expansion [6] as well.

Furthermore, perhaps the most important role to be played actively in prevention of such accidents at all the times; right from the installation of the induction furnace to its disposal is by the technical supervisors and maintenance staffs of the foundries. They should regularly check the condition of each and every part of the furnaces.
